HISTORIC RESOURCES INVENTORY FORM

- 1. BUILDING NAME: Common: _____ Historic: Danforth Pewter Shop
- 2. TOWN/CITY: Middletown VILLAGE: _____ COUNTY: Middlesex
- 3. STREET & NUMBER (and/or location): 120 College Street
- 4. OWNER(S): Farmer's & Mechanic's Savings Bank PUBLIC PRIVATE
- 5. USE: Present: Vacant Historic: Pewter Shop; apartments
- 6. ACCESSIBILITY TO PUBLIC: Exterior visible from public road: yes no
Interior accessible: yes, explain with owner's permission no

Danforth Pewter Shop
120 College Street, Middletown, Ct. 06457

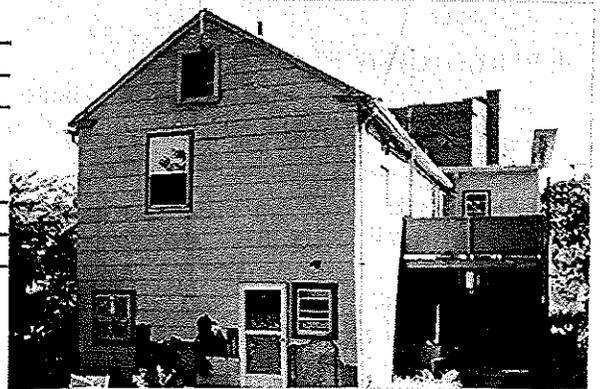
photographer: Robert Svec
date: 9/78 view: north
negative on file: Roll 31, #31

- 7. STYLE OF BUILDING: Italianate front applied to Colonial Shop DATE OF CONSTRUCTION: c. 1759
- 8. MATERIAL(S) (indicate use or location when appropriate):
 clapboard under siding asbestos siding ___ brick
___ wood shingle ___ asphalt siding ___ fieldstone
___ board & batten ___ stucco ___ cobblestone
___ aluminum siding ___ concrete: type: _____ cut stone: type: brownstone
___ other: _____ foundation

- 11. NUMBER OF STORIES: 2 APPROXIMATE DIMENSIONS: Italianate addition 30'x20'
- 12. CONDITION: Structural: ___ excellent good ___ fair ___ deteriorated
Exterior: ___ excellent ___ good fair ___ deteriorated

Cased beams
Original crown molding at cornice line
Some old sash remain

An Italianate front was added to the original structure probably when it passed out of the Danforth family in 1866. More recently the building was divided for use as apartments. A site investigation and an old map view recreate the approximate original appearance of the Danforth Pewter Shop. It displayed a two story, three-bay, gable-to-street facade with entrance in the east bay. The forge chimney stack (now removed) rose from the center of the 17'x35' structure. Danforth family probate records list assortments of pewter in the shop; it apparently was used as both store and shop. The second floor was probably
